FHWA/IN/JTRP-99/6

Final Report

**LANDSLIDE REMEDIATION USING
UNCONVENTIONAL METHODS**

Indiana
Department
of Transportation

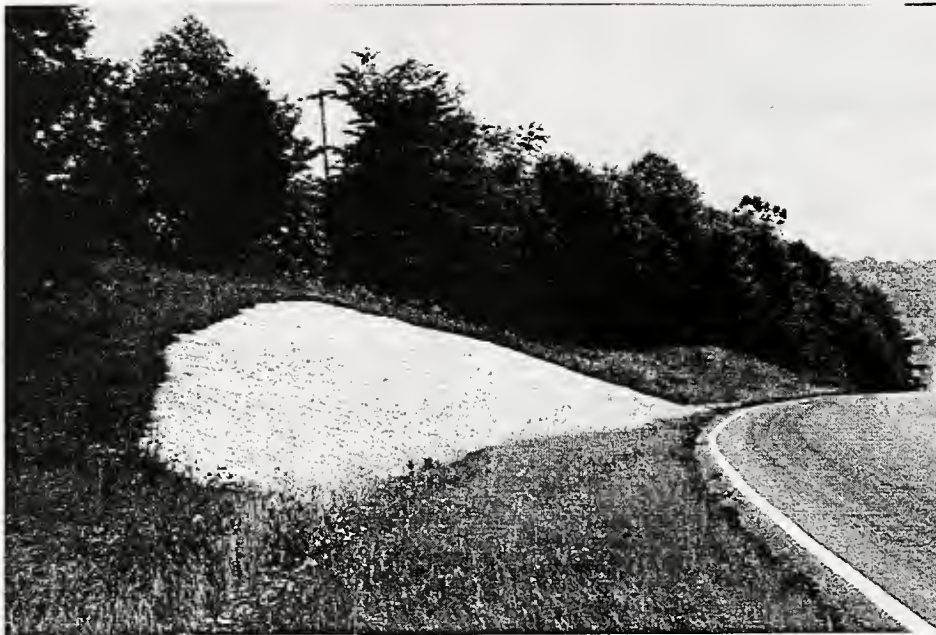
Figure 1. Landslide remediated using the excavation and backfill method on SR 64 in Crawford County.

The landslide remedial technique frequently applied by the Indiana Department of Transportation (INDOT) is the excavation and backfill method, which in most instances is successful. This method requires excavating the failed mass, sometimes constructing a key into competent material (to provide further stability), and backfilling the excavated portion with riprap (see Figure 1 and Figure 2). However, in many cases more liberal landslide treatments may be applied that would arrest movement, provide a sufficient safety factor, and at a lower cost. The objectives of this study are the proposal economically feasible landslide remedial methods and, the development of a landslide classification scheme, which recommends applicable remedial solutions based upon the landslide classification.

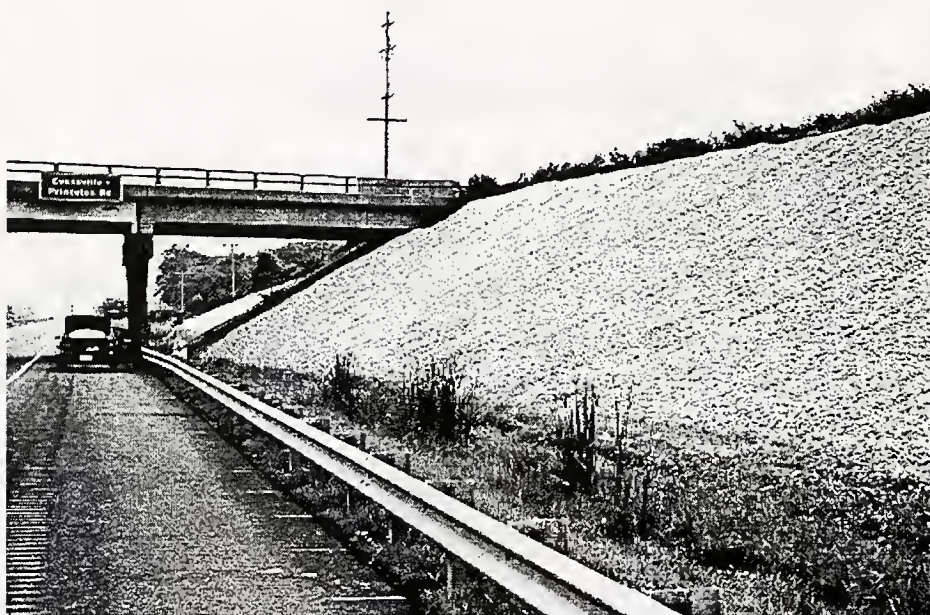
Figure 5. Cattails in ditch near toe of remediated landslide adjacent to I-64 in Vanderburgh County.

Vegetative cover was observed during field surveys and is described qualitatively within the inventory. Notice was taken to the presence of cattails, which are inherent in very wet areas where the groundwater table is high or perched water exists, indicating that the cause may likely be attributed to groundwater, and therefore, subsequent remedial action should incorporate subsurface drainage. Figure 5 is a photograph showing cattails in the ditch line at the toe of a corrected landslide.

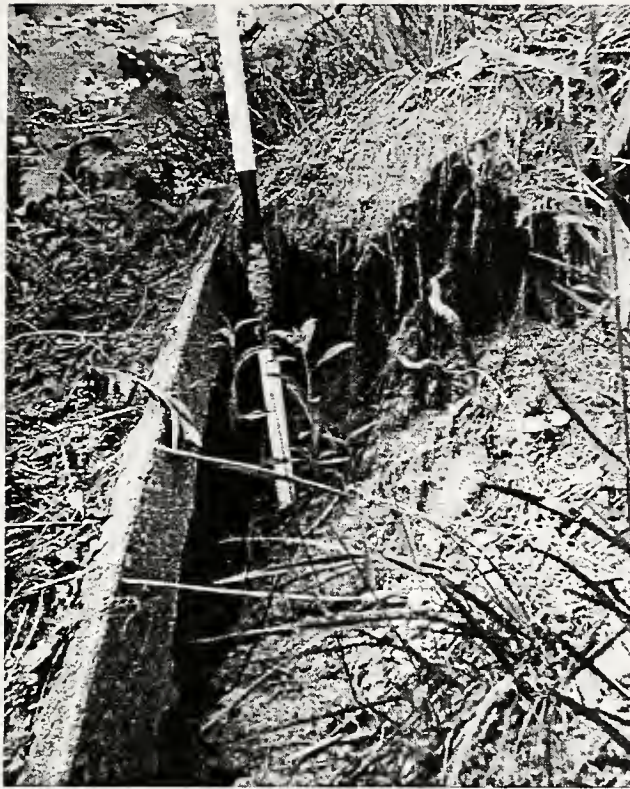
Figure 6. CPID at head scarp of landslide on SR 37 2.1 miles north of SR 54 in Lawrence County.

Twelve landslides are thought to have occurred due in some part to concrete paved interceptor (CPID) ditches that failed. Severe erosion often occurs parallel to the ditches between the edge of the CPID and the soil. Erosion opens channels for surface water to infiltrate into the subsurface, which may eventually cause failure. Figure 6 is a photograph showing erosion along a CPID that may have contributed to slope failure.

External drainage systems act indirectly to reduce groundwater levels by reducing infiltration, and are especially effective in reducing short-term infiltration during periods of intense and/or consistent precipitation. External drainage systems include interceptor and diversion ditches, and vegetation. INDOT often installs a concrete paved interceptor ditch (CPID) near the crest of cut slopes to divert overland flow from the slope crest. Erosion parallel to CPID's between the drainage structure and soil often occurs and may open infiltration paths within the soil mass acting counter to the intention of the design and thereby reduce stability. Figure 6 is a photograph showing erosion along a CPID that likely contributed to instability.

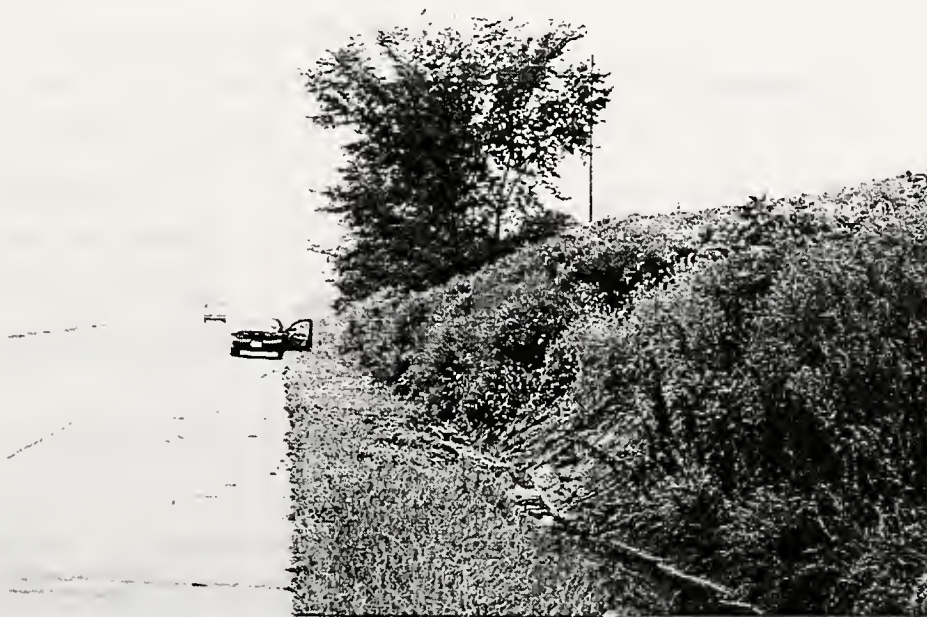
Figure 7. Fresh ditching at the toe of an active landslide adjacent to I-64 in Vanderburgh County.

Finally, for seven landslides it is thought that routine ditch maintenance may have caused instability, which removed needed toe support from the slope. Figure 7 illustrates recent ditching near the toe of an active landslide.

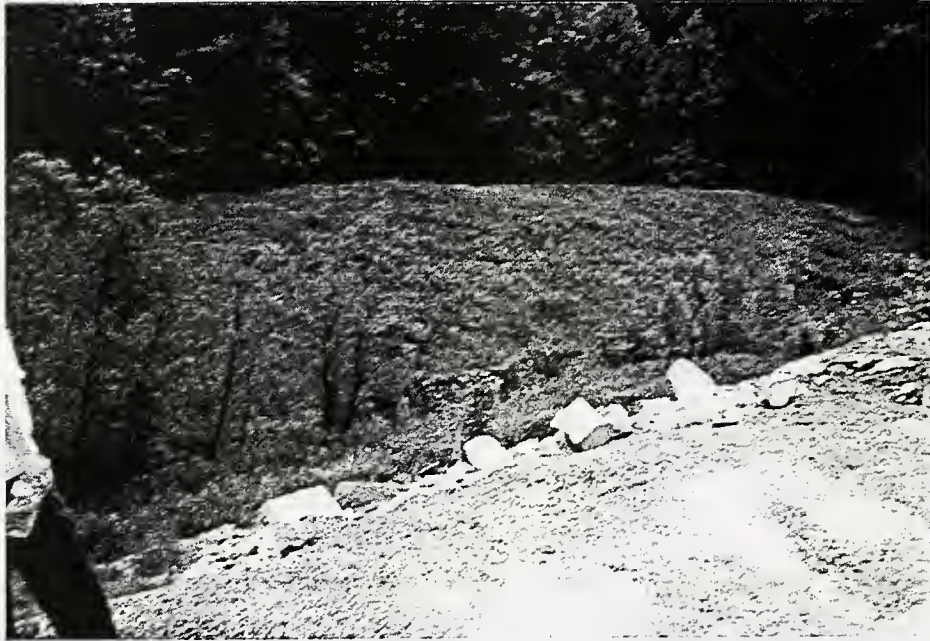
Figure 17. Erosion along riprap lined drainage ditch at toe of landslide on SR 450, 8.6 miles northeast of US 50 in Martin County.

Erosion can also occur near the toe of a landslide due to natural or man made drainage features. Whether a perennial stream, intermittent stream, or drainage ditch, during periods of intense or continuous precipitation, water flowing at the toe of a landslide may erode soil, which may lead to instability. Figure 17 is a photograph showing erosion at the toe of a landslide due to a small ditch running parallel to the base of the slope.
